**Site Inspection  
Granite Creek Mines  
Wallowa-Whitman National Forest, Oregon**

U.S. Department of Agriculture–Forest Service  
Wallowa-Whitman National Forest  
Baker City, Oregon 97814

EA Engineering, Science, and Technology, Inc.  
12011 Bellevue-Redmond Road, Suite 200  
Bellevue, Washington 98005

January 2004  
FINAL  
Project No. 13890.13

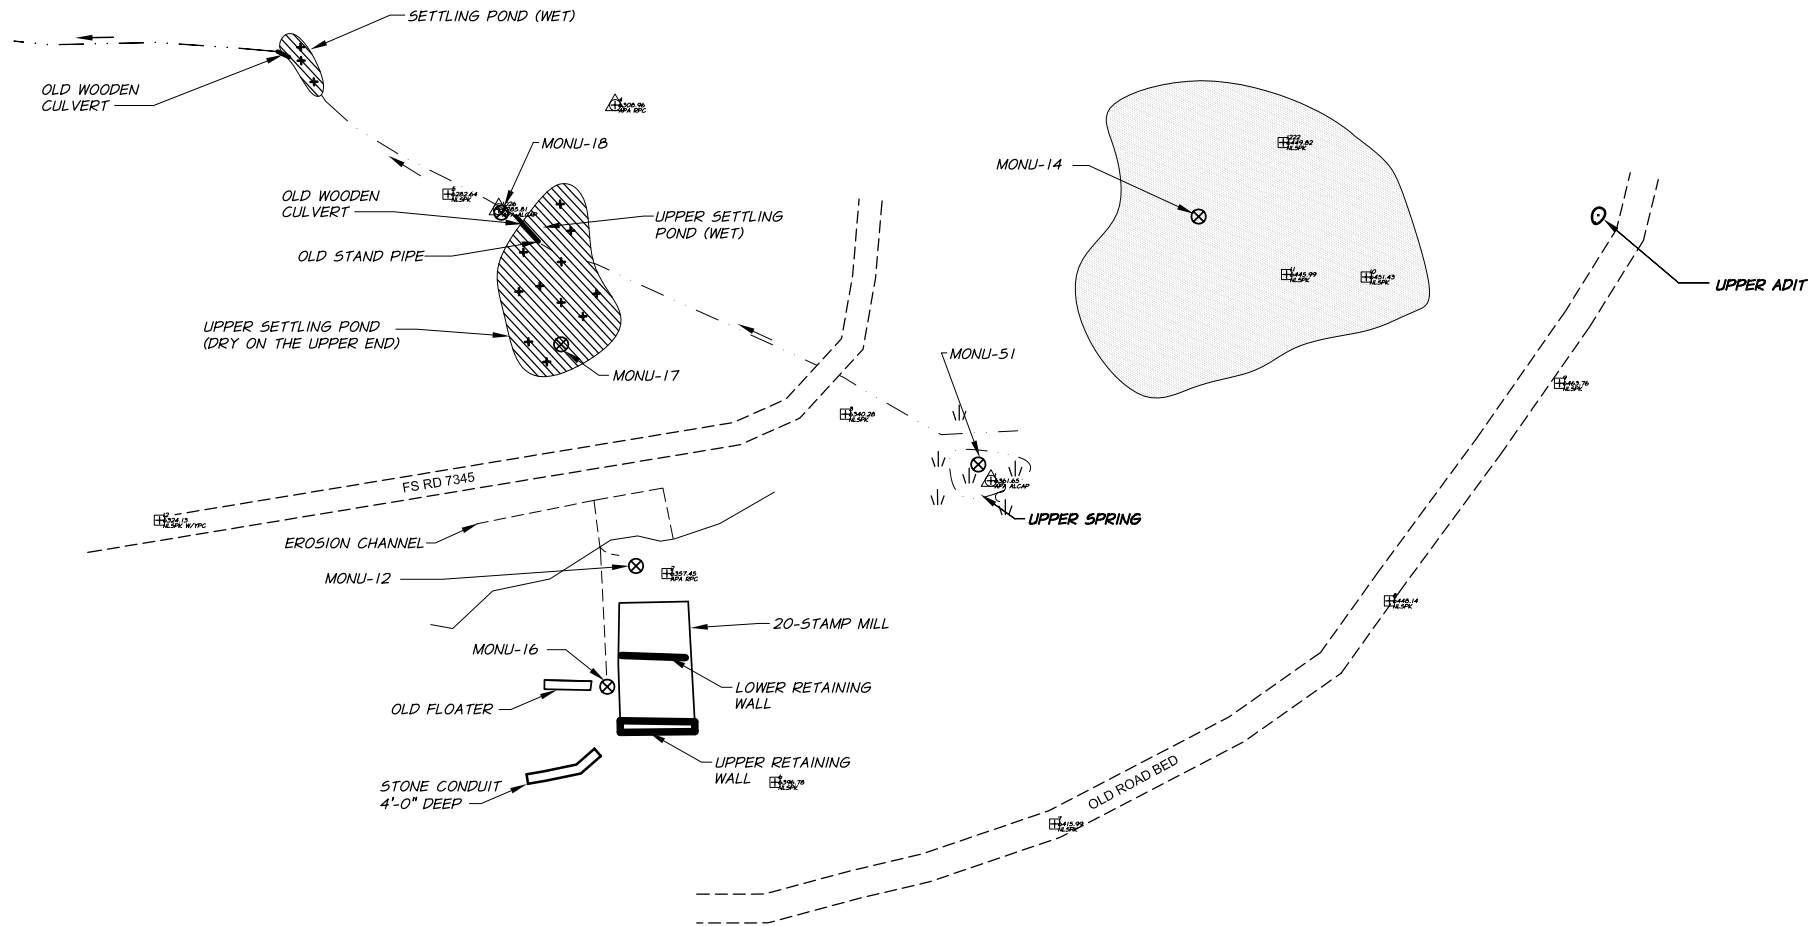
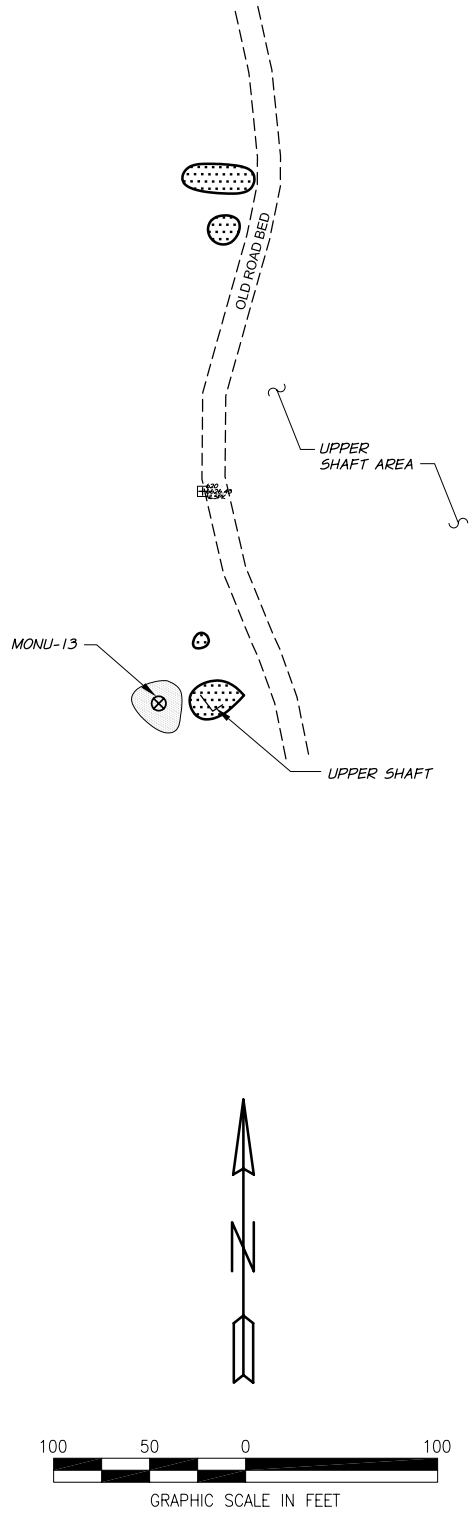
Figure 1a. UPPER MONUMENTAL MINE SITE

- **Monumental Mine.** Flow from the upper spring drains under FS Road 7345, through the upper and middle settling ponds and eventually collects in the downstream pond, where flow from the lower adit also collects (Figures 1a and 1b). No outlet from the lower pond was observed during the field investigation. An unnamed tributary, which is part of the headwaters of the Granite Creek drainage, forms in a marshy area located downhill from the lower adit and waste pile. The tributary flows into Granite Creek between the Cap Martin and Sheridan mines (Figure 3).

Locations of stream and spring samples collected during the field investigation are indicated on Figures 1a, 1b and 2 through 5. A number of modifications to the sampling locations and techniques were made in the field, based on site observations and field conditions, and with concurrence of the Forest Service OSC. These modifications are documented in Appendix A in Table A-1. The stream sampling locations, as well as the on site surface water sample locations are described in Table A-2 (also in Appendix A).

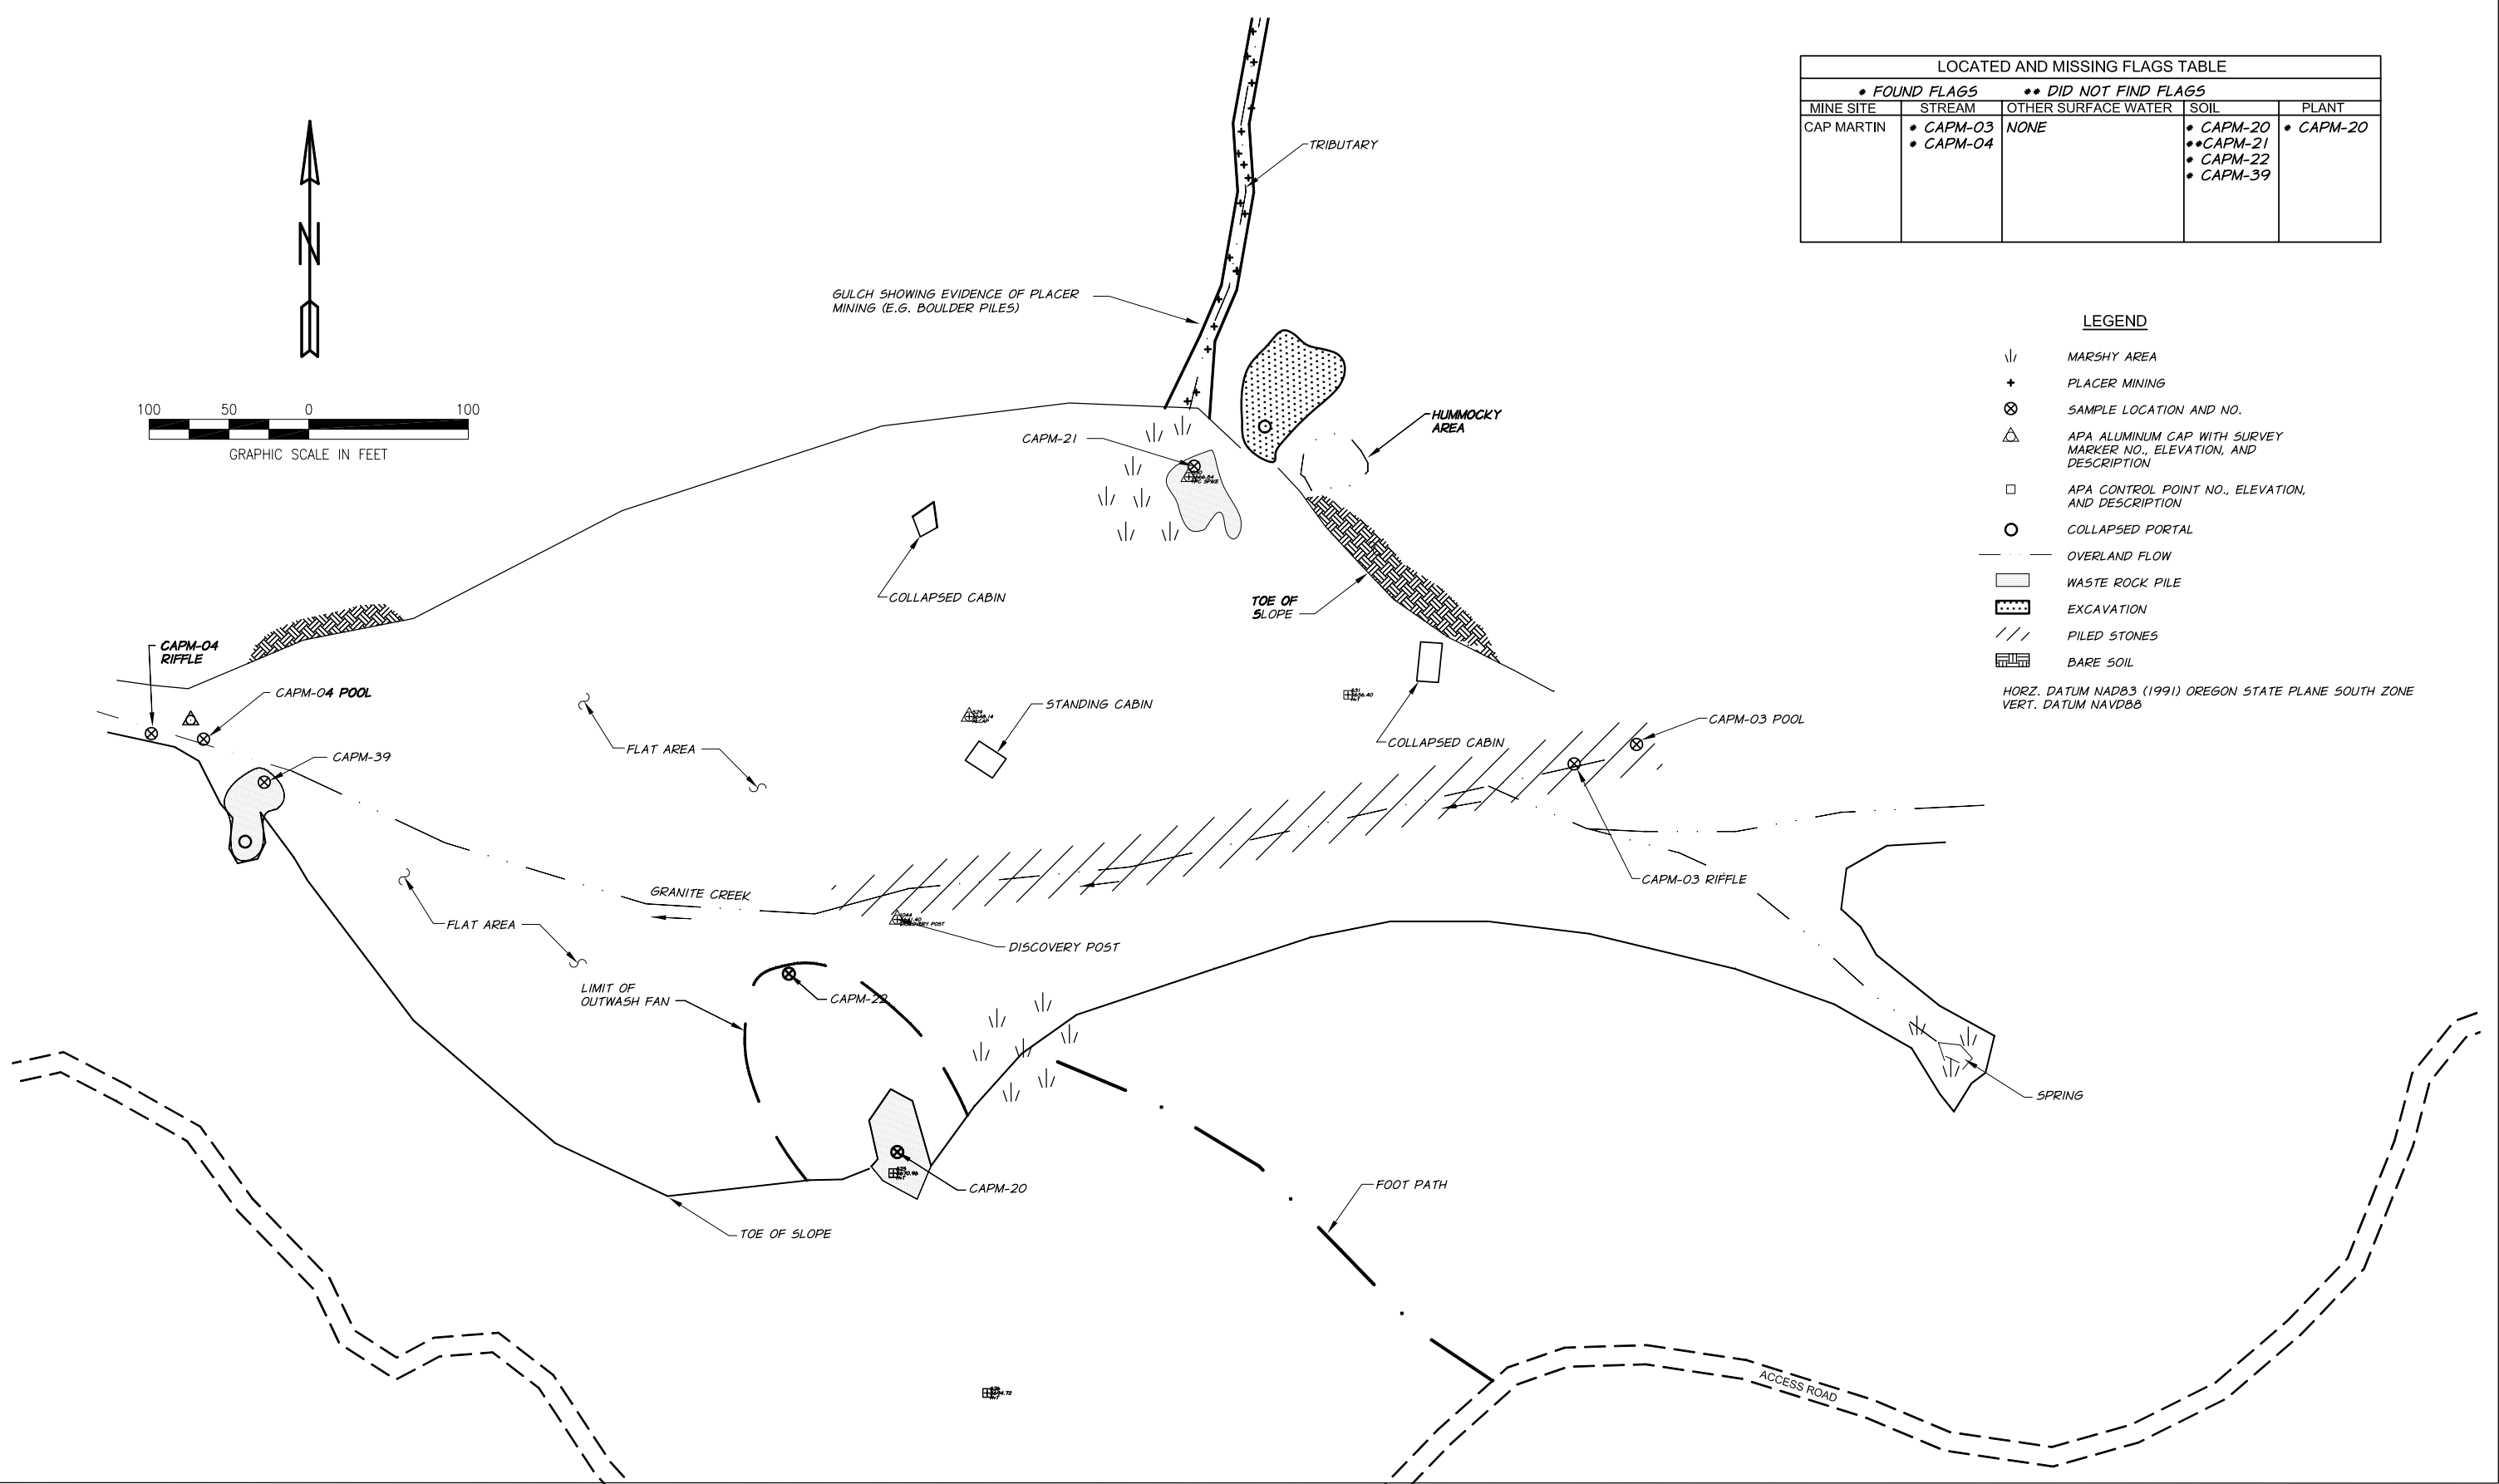
Figure 2. CAP MARTIN MINE SITE

- **Cap Martin Mine.** An unnamed stream flows through a wide ravine located in the northern portion of the site. The creek flows from under the access road located north and upgradient of the site and eventually forms a marshy area near the collapsed cabin (Figure 2). The ravine has been altered significantly by placer mining, as evidenced by boulder piles located all the way up to the access road. There is also a large amount of downed timber in this area. Evidence of placer mining (i.e. piled stones) was also observed along Granite Creek. A small tributary, as well as flow from a spring, form part of the headwaters of Granite Creek immediately upstream of the site.

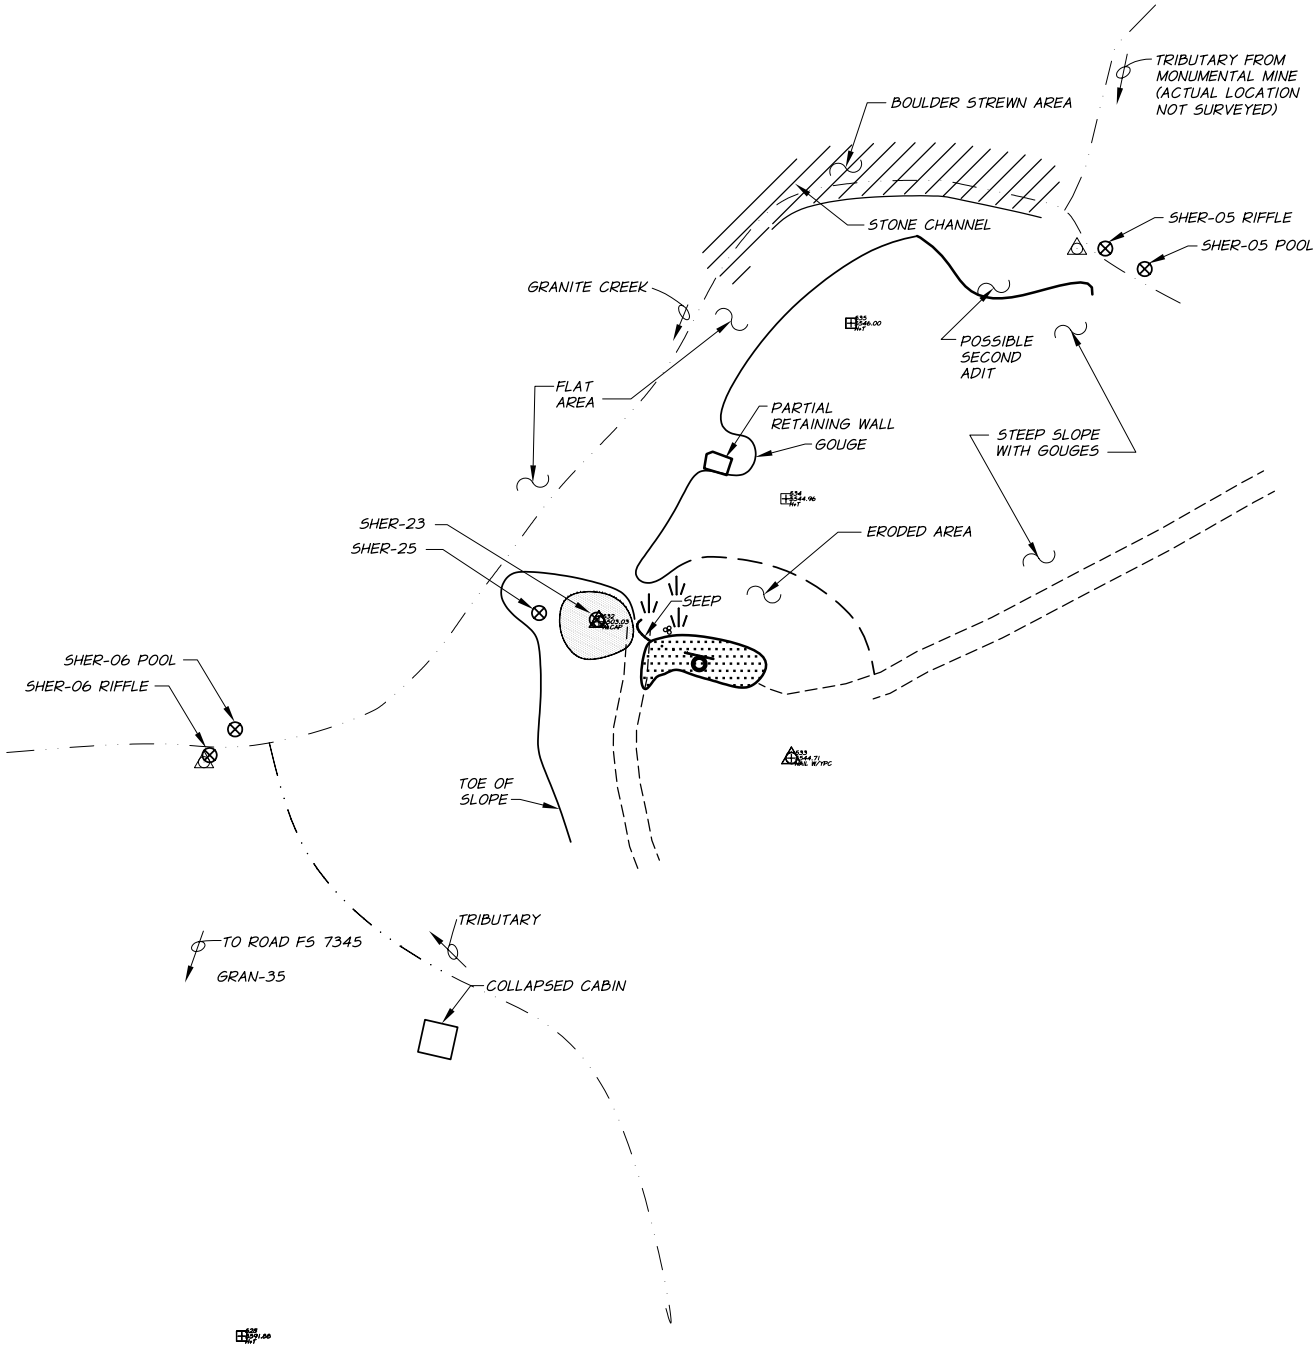
Figure 3. SHERIDAN MINE SITE

- **Sheridan Mine.** Granite Creek near the mine site has been significantly altered by placer mining, as evidenced by large boulder piles and stone channels (Figure 3). Two tributaries enter Granite Creek in the area of the mine: one which flows from Monumental Mine on the north side of the creek and the other from the south side of the creek. There is also a seep near the collapsed portal that forms a marshy area upgradient of the waste pile. No staining or mineralization was observed in this area.

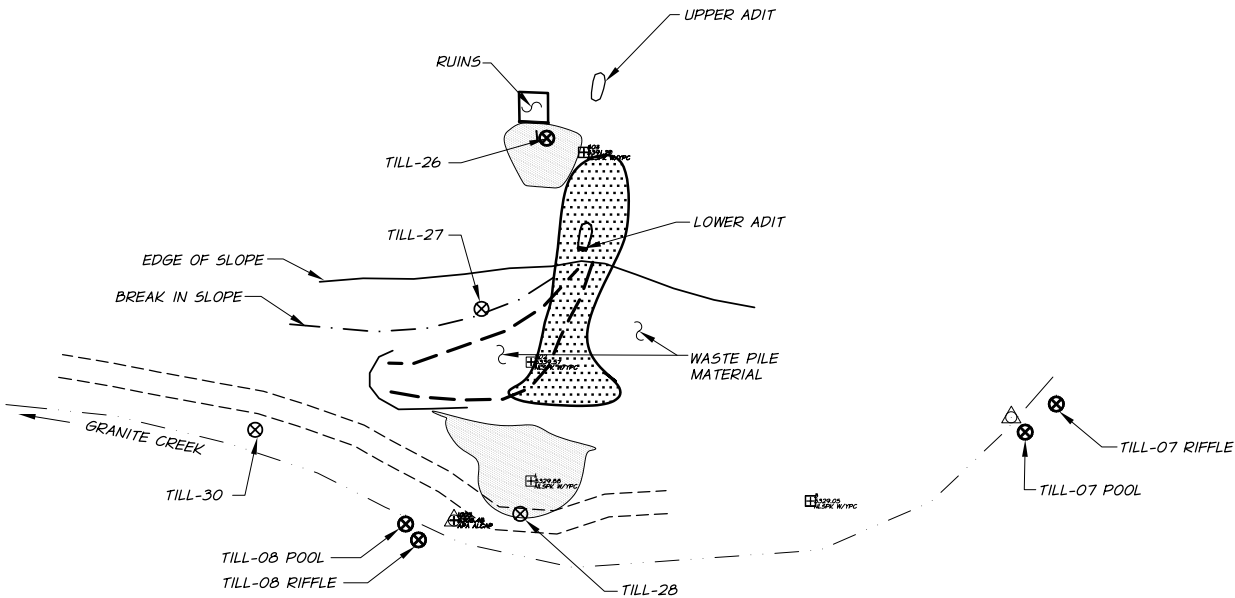
Figure 4. TILlicum MINE SITE

- **Tillicum Mine.** No overland flow was observed at the mine site during the field investigation. Two erosion channels (dry during the field investigation) were observed coming from the collapsed adits and lower waste pile (Figure 4). No staining was observed along the channels. Water likely runs through these channels over the waste material during periods of high rainfall and snowmelt.

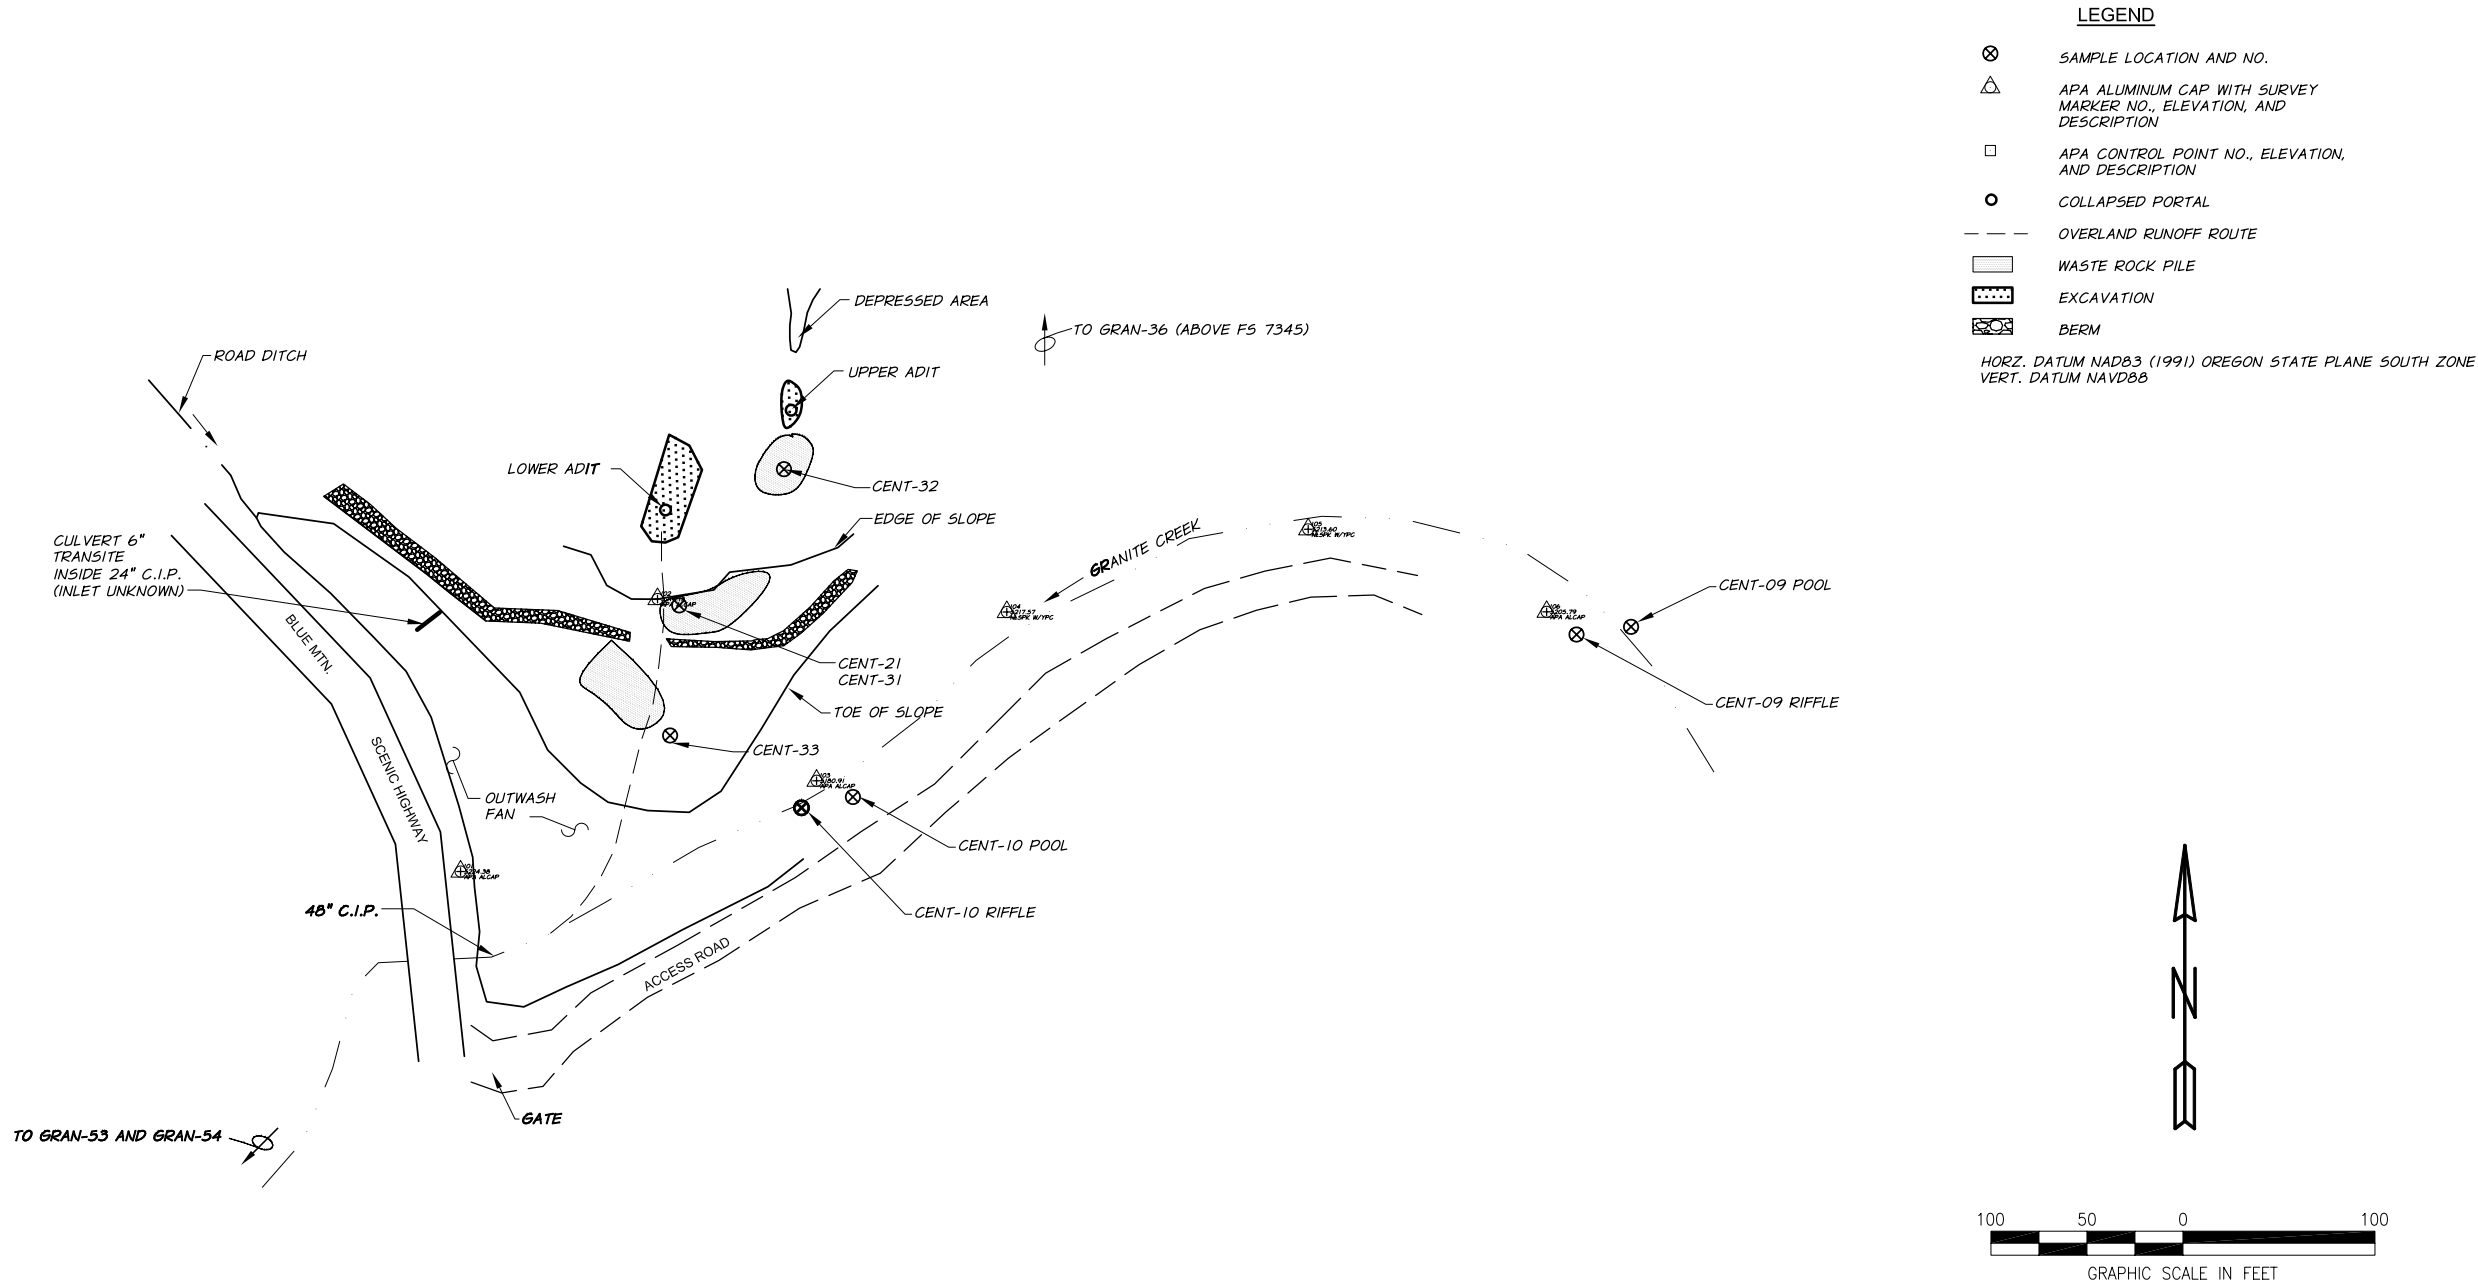
Figure 5. CENTRAL MINE SITE

- **Central Mine.** No overland flow was observed at the mine site during the field investigation. A runoff channel (dry during the field investigation) was observed coming from the waste pile near the lower adit (Figure 5). Water likely runs through this channel into Granite Creek during periods of high rainfall and snowmelt. A waste rock berm, the result of hydraulic mining activities, was observed along the slope above the creek. Immediately downstream of the mine, Granite Creek flows under the Scenic Highway through a large culvert.
